COMPARISON OF LONG-TERM AND SHORT-TERM TESTS FOR ELECTROFUSION JOINTS IN PE PIPES

Mike Troughton, Chris Brown TWI Ltd
Joachim Hessel Hessel Ingenieurtechnik GmbH
Marco Piovano Italgas S.p.A.

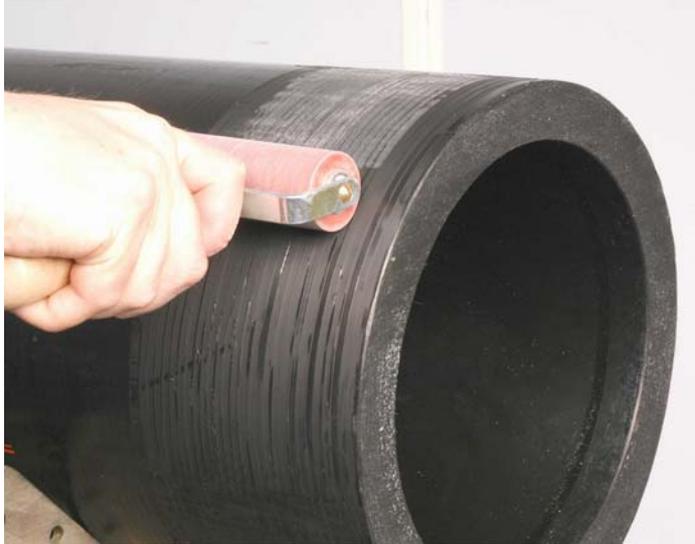
Fig.I Application of particulate contamination.

The particulate contamination was applied to the scraped surface of the pipe to be welded using a rubber roller (see Fig.1). The talc (Westmin D100) had a median particle size of

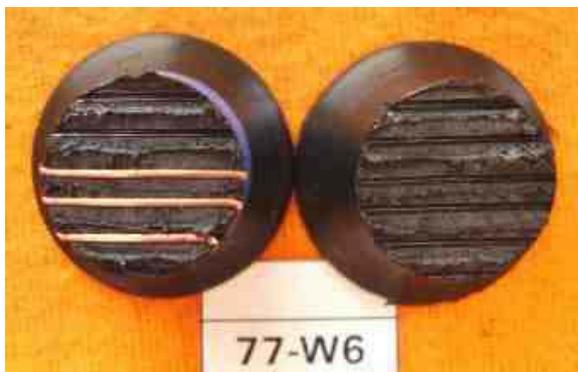
Fig.X Fracture surface of tensile creep test specimen through the plane of the heating wires.

As can be seen in the above table, the welds containing no flaws, sand contamination and unscrapped pipes all failed through the plane of the heating wires (see Fig.X). Even though the average times-to-rupture for these specimens are different, this cannot be due to the flaws because the failures were not through the weld interface. Two out of the six specimens containing talc contamination failed through the weld interface (Fig.XI), with one specimen failing partly through the weld interface and partly through the plane of the heating wires (Fig.XII). Also, the average time-to-rupture for these specimens was lower than for the welds with no deliberate flaws.

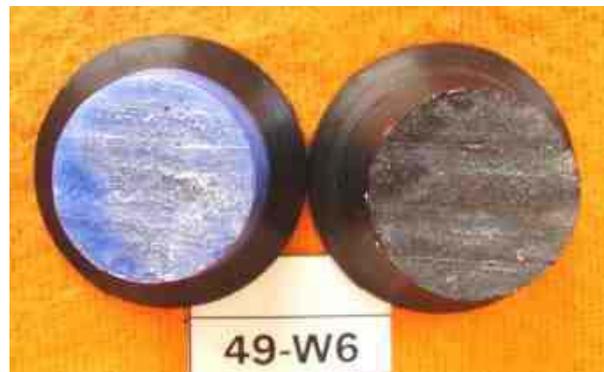
Fig.XI Fracture surface of tensile creep test specimen through the weld interface.

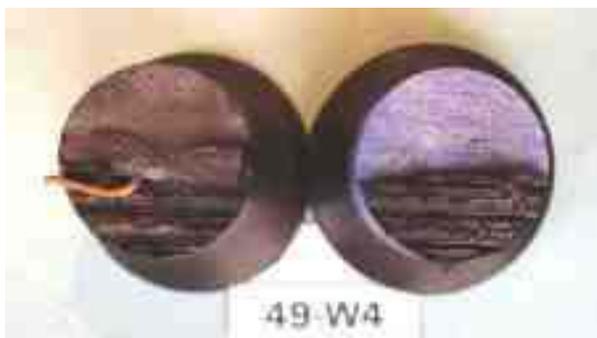
Fig.XII Fracture surface of tensile creep test specimen showing a mixed failure mode.

Two of the specimens containing cold welds also failed partly through the weld interface and partly through the plane of the heating wires, with the remainder failing fully through the plane of the heating wires. The average time-to-rupture for the cold weld specimens was very similar to average value for the welds containing no deliberate flaws.
